Load Capacity of a Jack-Arch Bridge

RESEARCH REPORT 129

**ENGINEERING RESEARCH AND DEVELOPMENT BUREAU
NEW YORK STATE DEPARTMENT OF TRANSPORTATION**

1. Report No. FHWA/NY/RR-85/129	2. Government Accession No.	3. Recipient's Catalog No.	
4. Title and Subtitle LOAD CAPACITY OF JACK-ARCH BRIDGES		5. Report Date December 1985

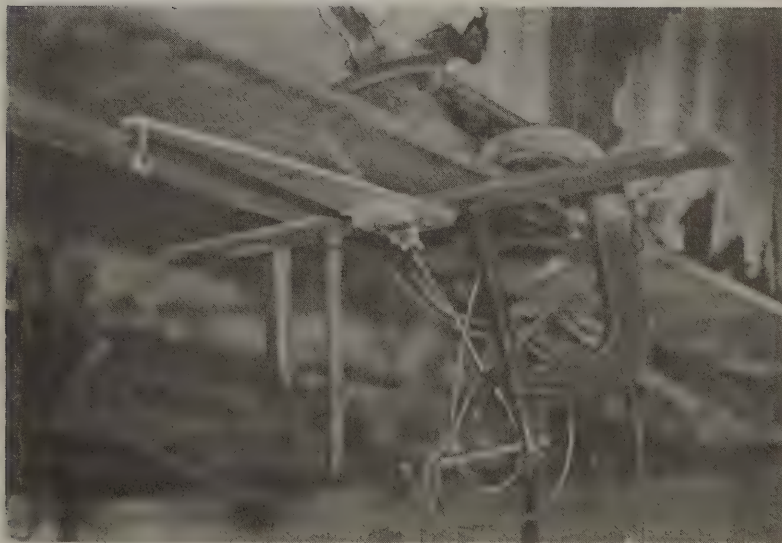
Figure 5. Displacement device.

Primary deflection measurements were obtained with deflectometers mounted at midspan of each girder. These devices consist of an aluminum cantilever beam fixed at one end to the object to be monitored and at the other end to a rigid support beneath the structure (Fig. 5). Displacement of the object induces strain in the cantilever beam which is sensed with electrical-resistance strain gages. The devices are calibrated to provide deflection measurements to the nearest 0.001 in., but values are reported to the nearest 0.01 in. to reflect the accuracy obtainable in the field. A Wilde N-3 level was used as a backup and to monitor the ends of the beams to detect any support movements during the test.

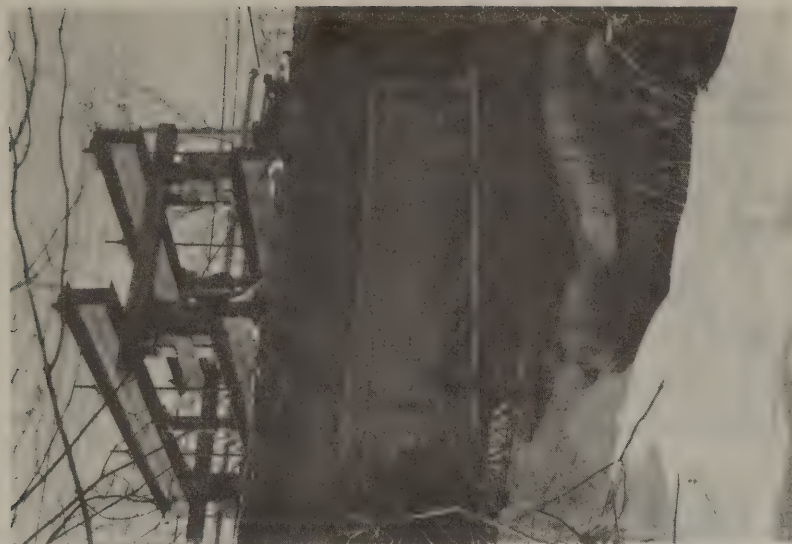
Figure 7. Loading system.

Test loads were applied by jacking against two load-distribution beams, each restrained by four soil anchors. Jacking loads were applied to the structure

through two transverse bearing-beams spaced at 6 ft and centered on the bridge's midspan. Details of the loading system are shown in Figure 7. As detailed, the load system proved unstable and diagonal lacing members were added to tie the two distribution beams together. The hydraulic rams were operated from a single pump through a manifold. Loads were monitored with electrical load cells placed in series with the rams.
